# Noise Monitoring Report

Bowral Waste Centre - EPL 13366

May 2022

Report reference: 20190601BOW – Noise Report 2021-22

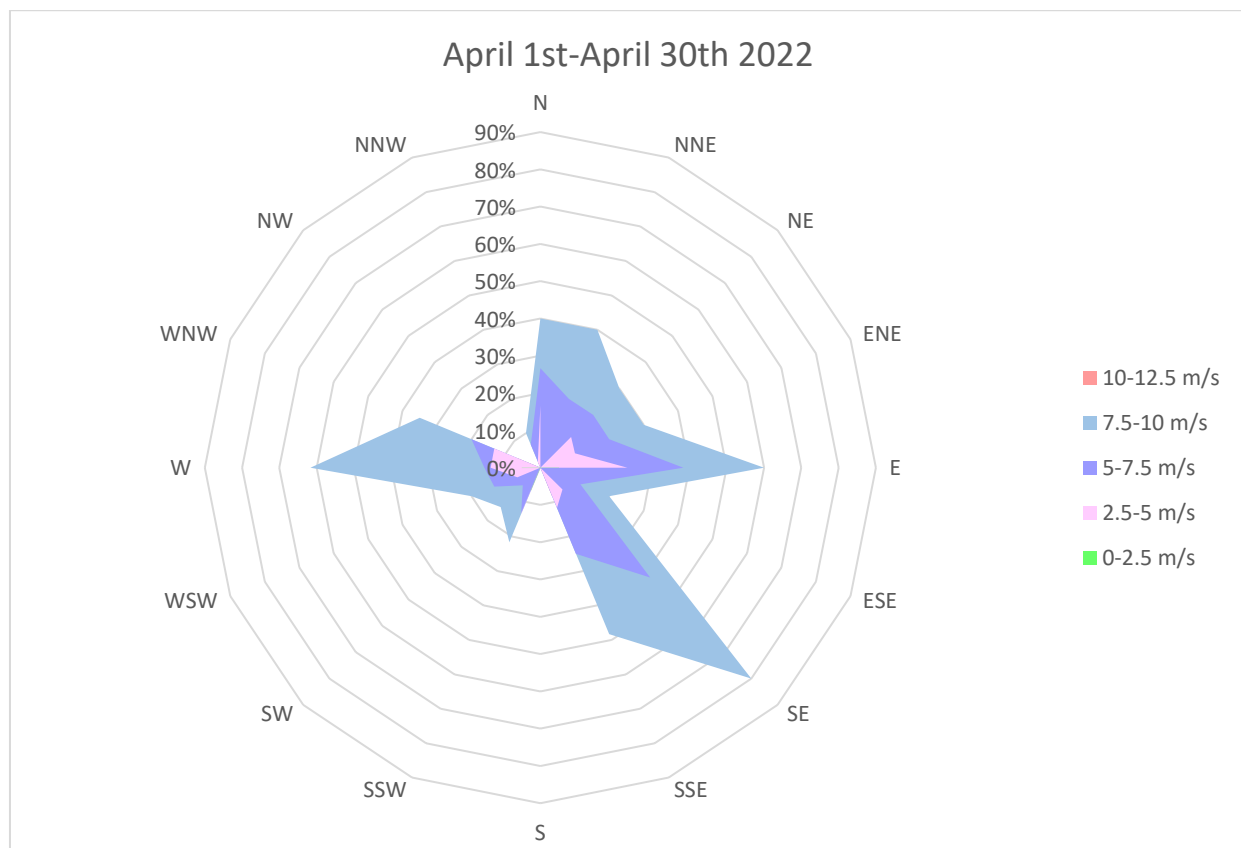
Figure 1: Windrose from Moss Vale AWS (Station ID 068239) for 1 April to 30 April 2022 (from 09:00 to 15:00).

Sampling took place between 13:33 and 15:37 on 14 April 2022. During this time, the average temperature was approximately 18°C and cloud cover was low with no rainfall. A wind rose for the month in which the monitoring period occurred is presented in Figure 1. The wind rose indicates that for the period of monitoring, winds from the west, south-east and east were dominant. The average wind speed for the period was 5.2 m/s and the percentage occurrence of calm wind conditions was 5% (speed less than or equal to 0.5 m/s).

The meteorological conditions during sampling sessions met the criteria for 'noise-enhancing conditions' under Table D1 of the EPA's *Noise Policy for Industry 2017*. The policy states that light to moderate daytime winds, temperature inversions and source to receiver winds have the potential to increase noise levels. As average wind speeds greater than 3 m/s were present at the time of sampling, there is a possibility that noise levels were enhanced. The impact of weather and extraneous noise sources downwind during readings has been taken into account when estimating the operational noise levels.

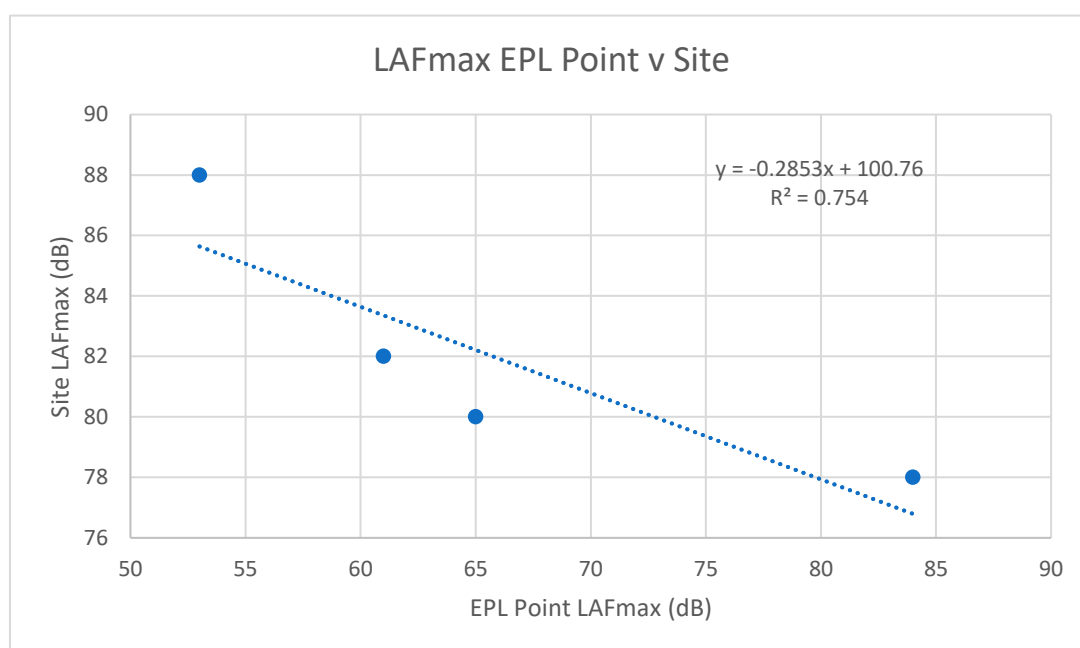
Figure 2: Comparison of LAFmax values during each monitoring session at each EPL Point and the comparison logger (i.e., Site noise source). A linear trendline has been included. Note: For values that were determined to be “less than the limit”, the limit has been entered.

To determine whether there was a clear correlation between the values obtained for each monitoring location and the Site noise source, the results obtained were compared to those from the comparison logger, following identical statistical analyses as the monitoring location results. Simple correlation plots were prepared for the LAFmax (15 minutes) values are shown below in Figure 2. Note, the plot has been prepared based on the values obtained following the three-stage assessment process, and therefore do not account for all data points. Furthermore, where values were determined to be “less than the limit”, the limit has been used in place of a calculated value.
