Landfill Gas Monitoring Report

EPL 13366

July 2023

Report reference: 20190701BOW_GasMonitoring-202307

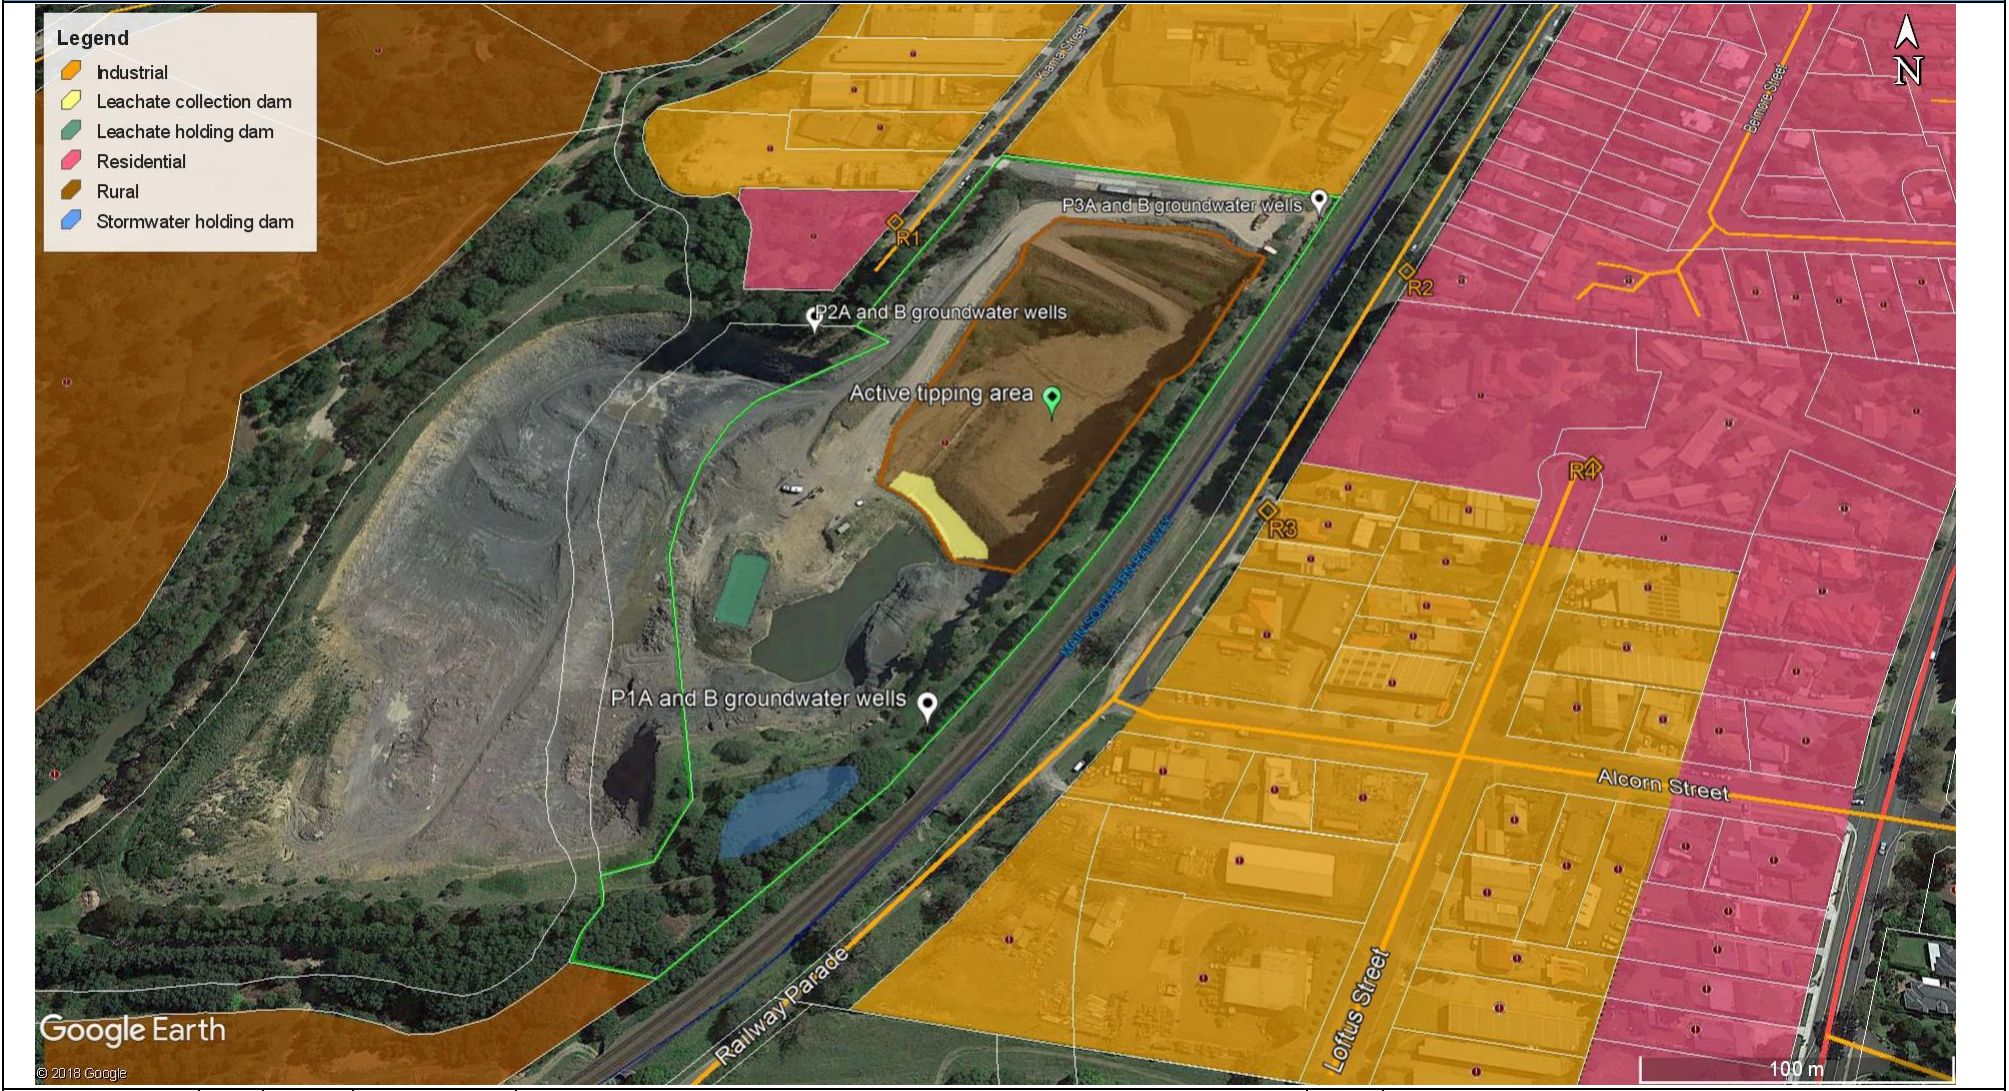
Drawn by:	JH	Date	25/05/2017	Report reference:	20190701BOW_GasMonitoring-202302	Key:	Orange points: Receivers Green line: Site boundary
Reviewed by:	TN	Date	29/07/21	Image source:	Google Earth Pro		Dark blue line: railway Other polygons: as per legend

Figure 1: Simulated oblique image showing Site layout, key features and nearby sensitive receivers.

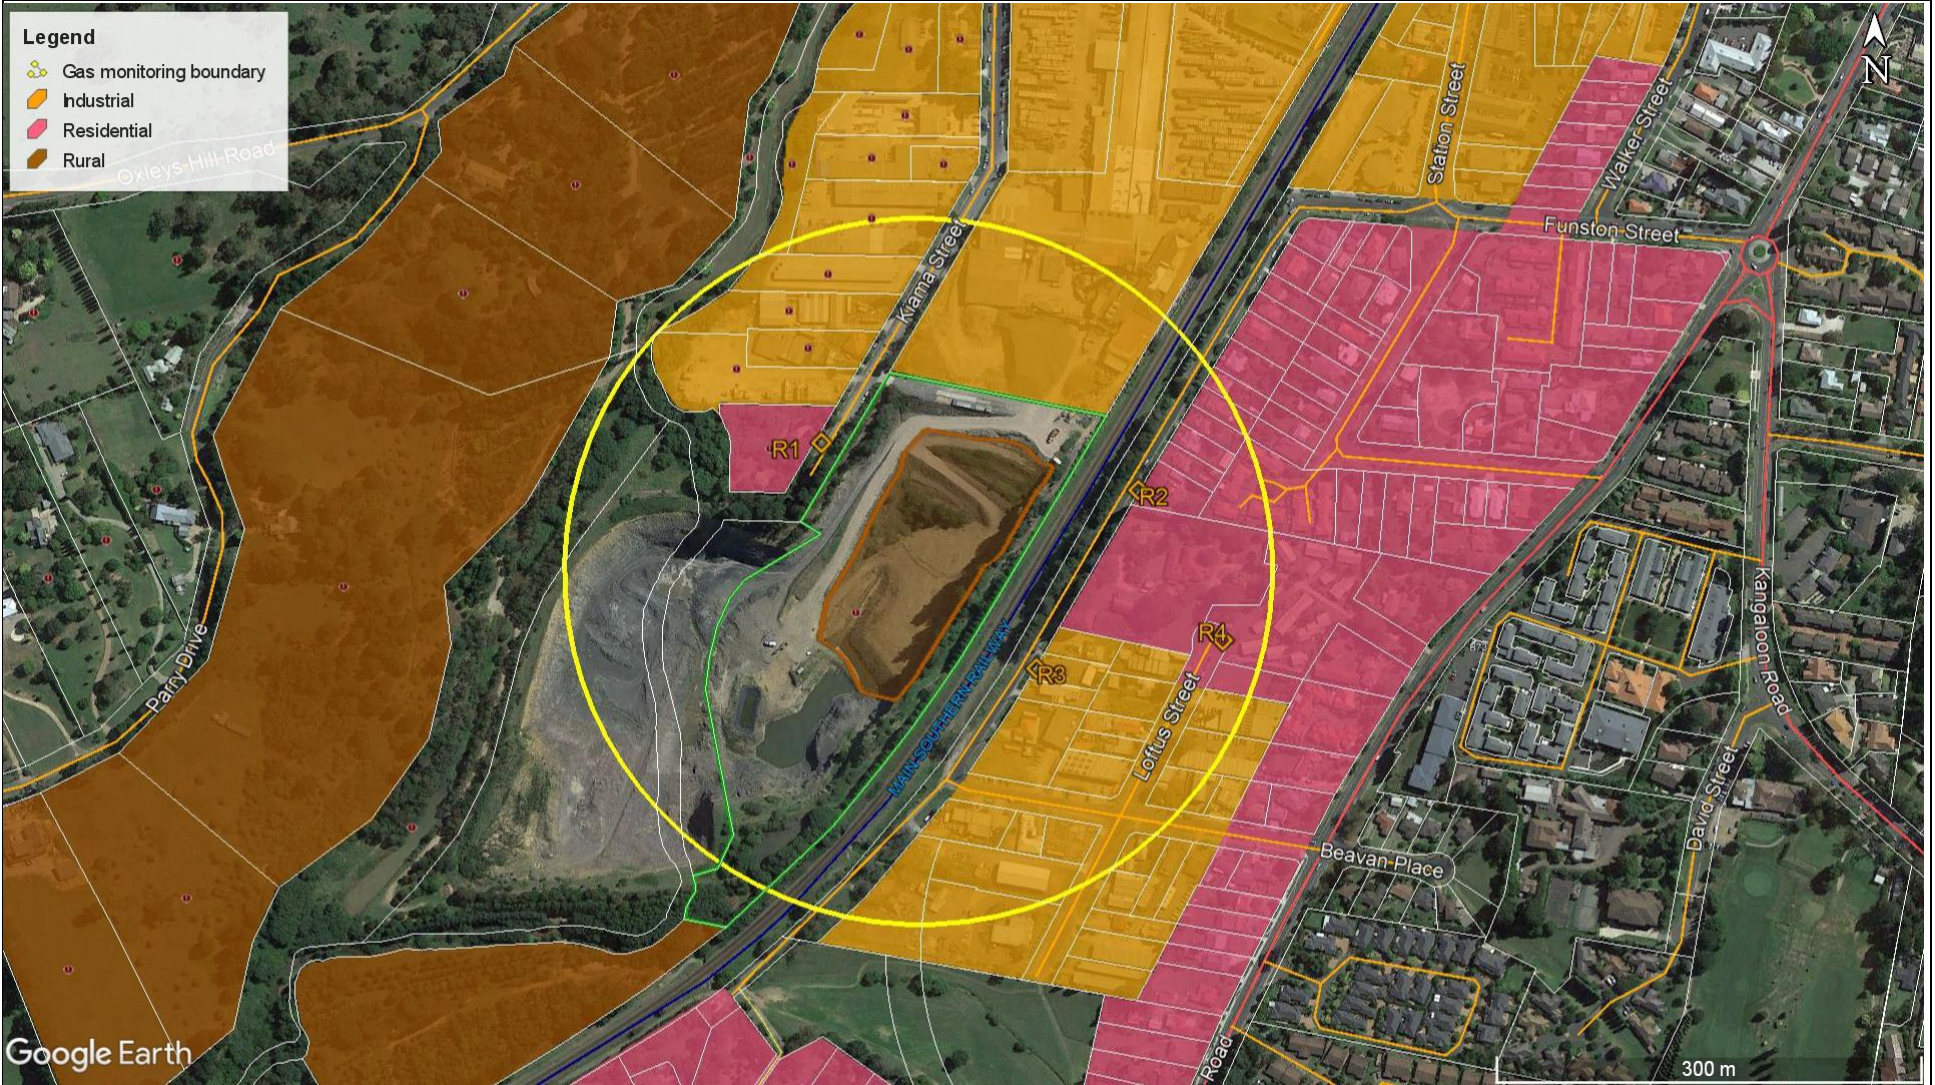
Drawn by:	JH	Report reference:	20190701BOW_GasMonitoring-202302	Key:	Brown polygon: active cell Other features: see legend
Date:	29/07/21	Image source:	Google Earth Pro		Yellow circle: 250m buffer around centre of active cell

Figure 2: Figure showing all properties with buildings within a 250 m radius of deposited waste. The purple and light green lots fall within the scope of gas monitoring.

Neither intermediate nor final cover was placed in the landfill on the day of monitoring; therefore, landfill gas measurements were not taken on the active cell. As per the Site's EPL, the measurement of methane in buildings within 250 m of deposited waste (see Figure 2) was undertaken.
