# Landfill Gas Monitoring Report

EPL 13366

February 2023

Report reference: 20190701BOW\_GasMonitoring-202302

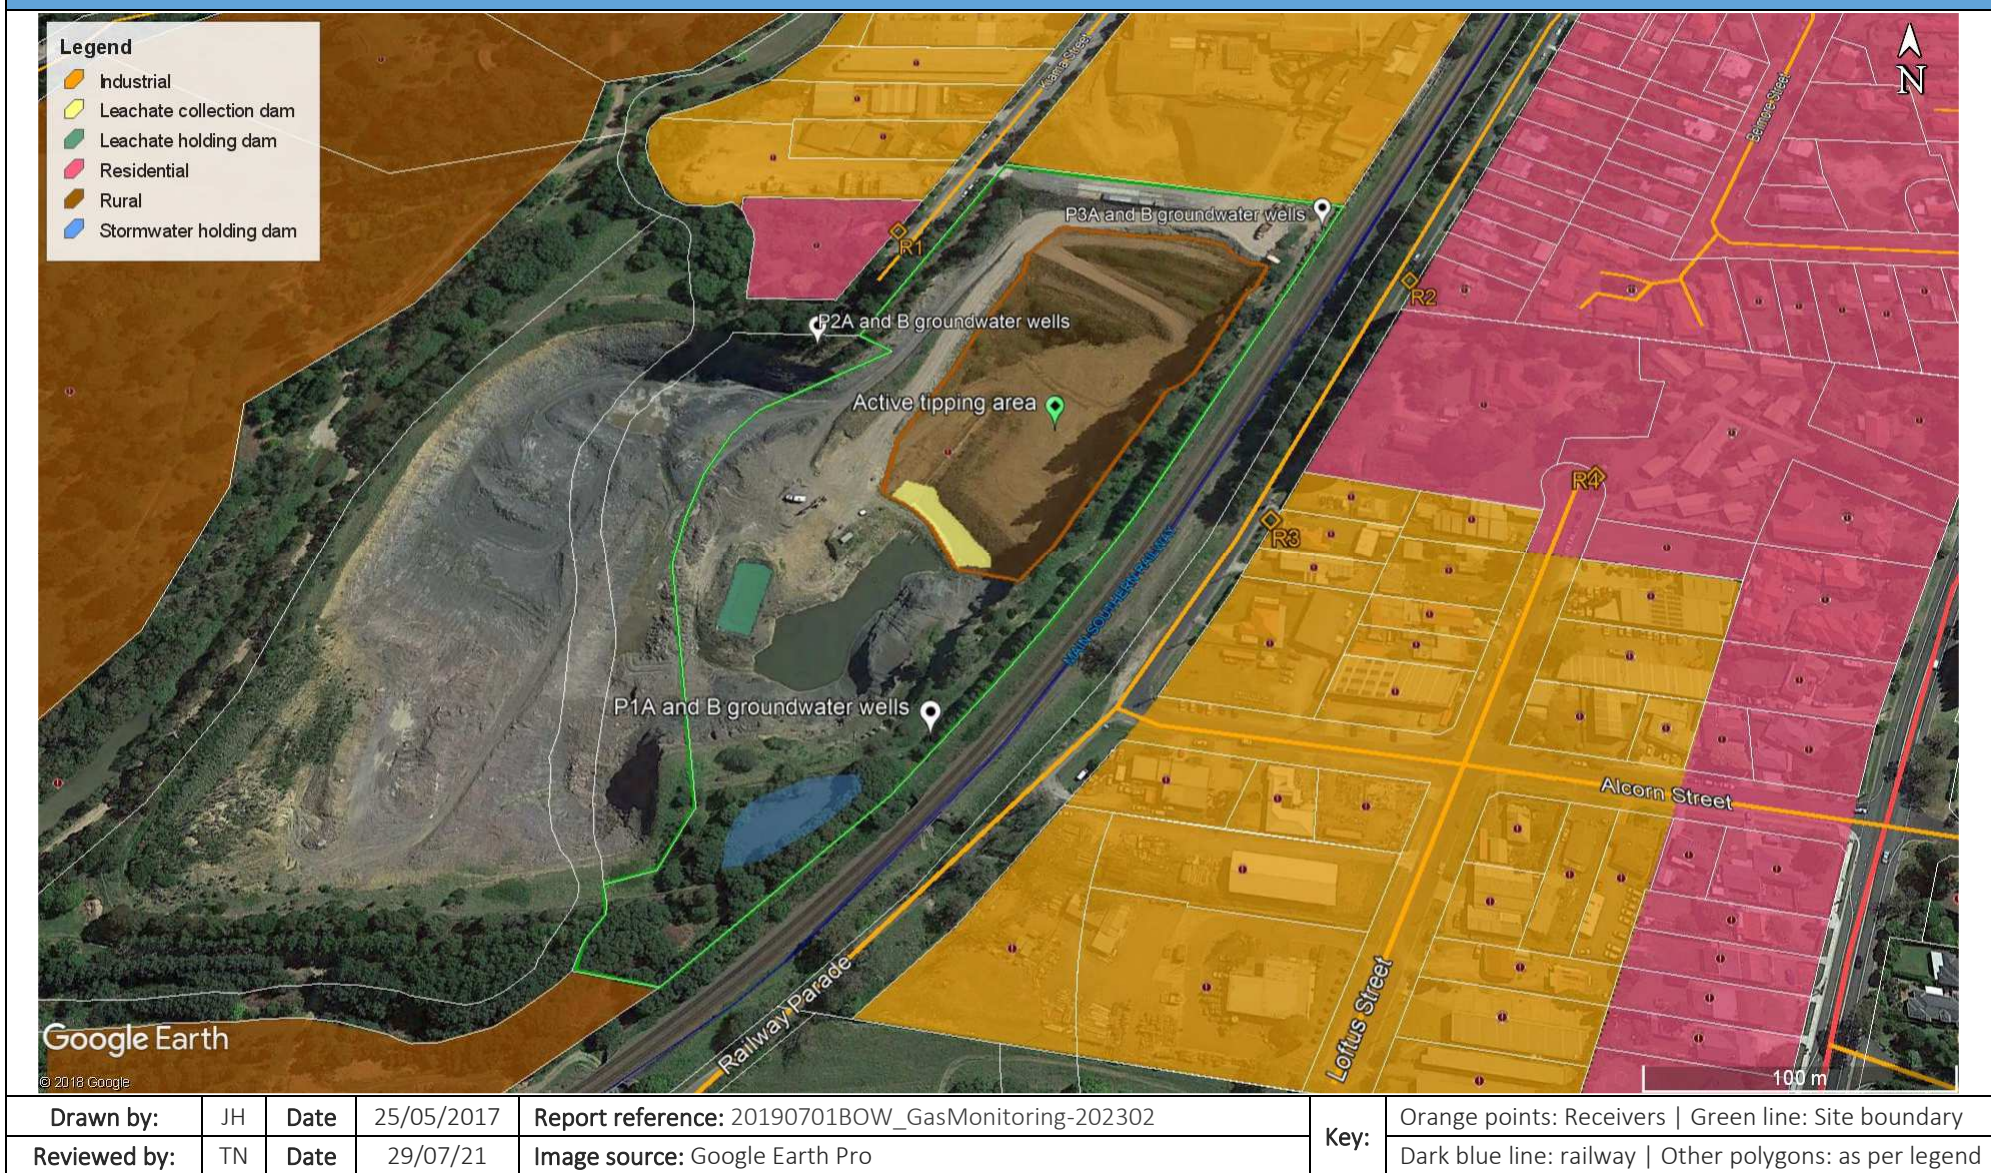
Figure 1: Simulated oblique image showing Site layout, key features and nearby sensitive receivers.

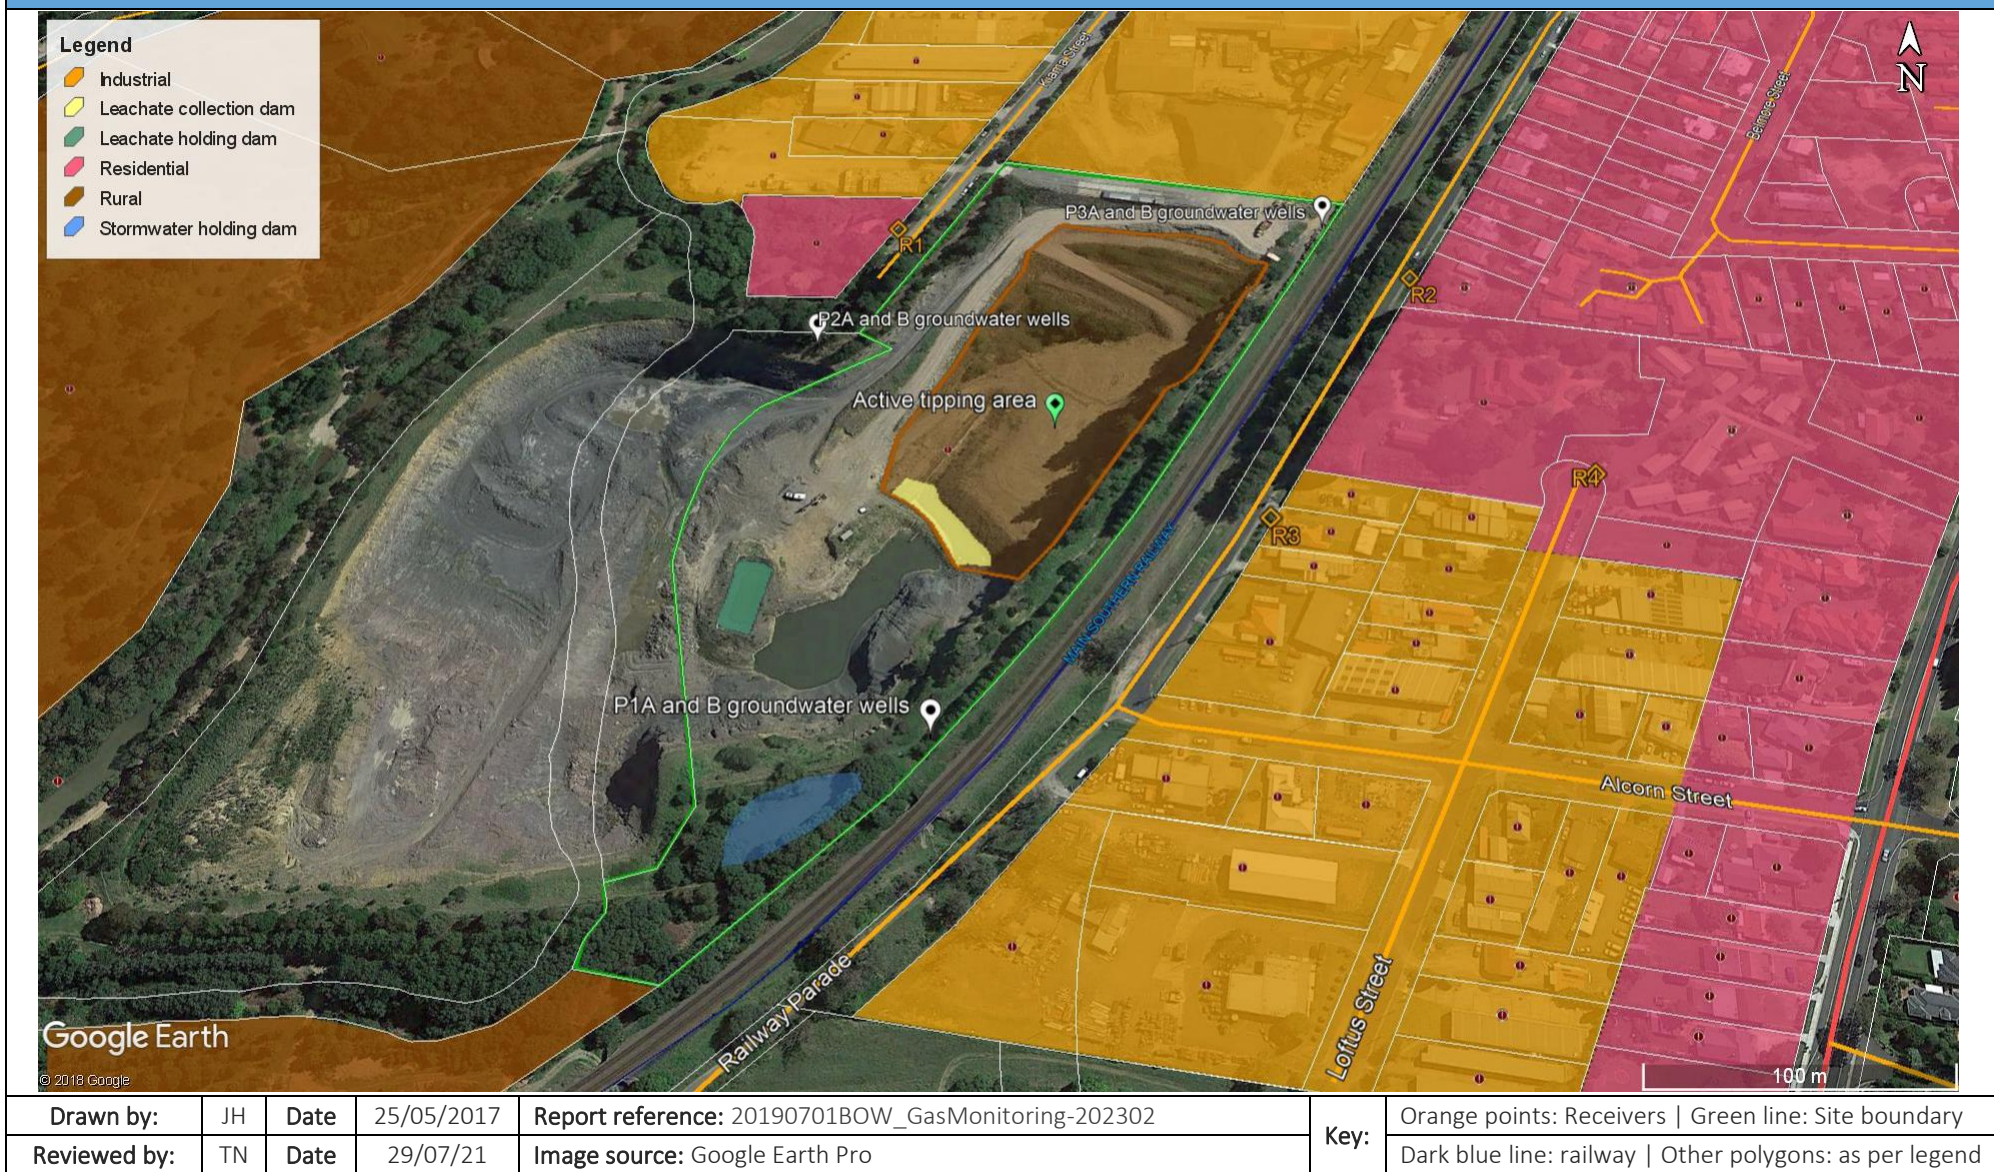
Figure 1: Simulated oblique image showing Site layout, key features and nearby sensitive receivers.
